East Texas Ag Services

Photo Log

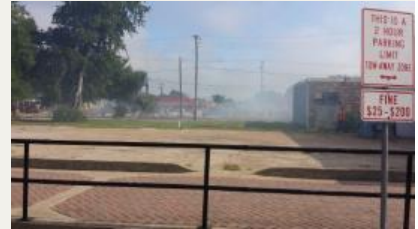
Description: View of smoke from fire (looking north).

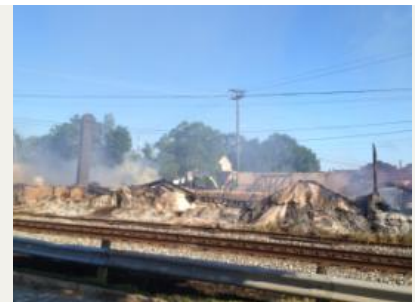
Description: A back hoe was used to knock down the cinderblock walls of the facility in order to contain the fire.

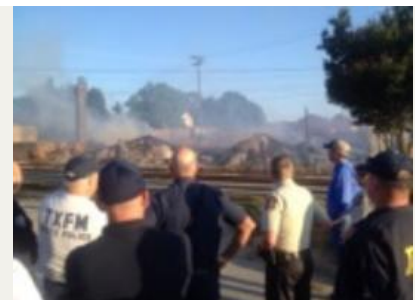
Description: Response crews stand back and assess the fire from the south on the morning of 30 May 2014.

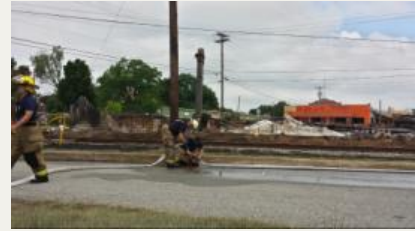
Description: Athens Fire Department suppressing fire on morning of 30 May 2014

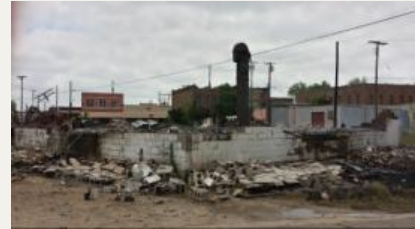
Description: View of facility after fire was extinguished.

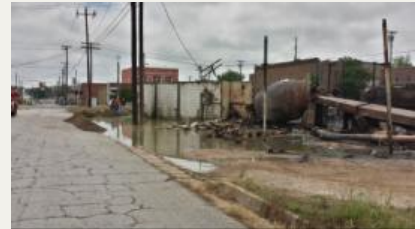
Description: View of containment berm along northern edge of facility to prevent migration of firefighting water.

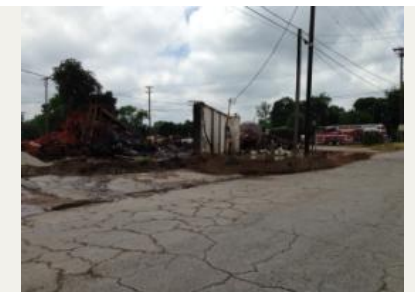
Description: View of facility following fire.

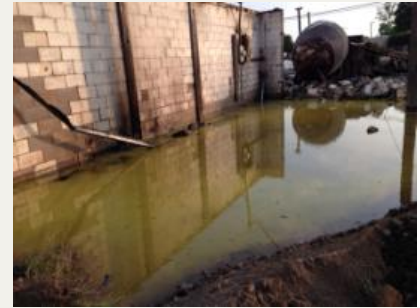
Description: View of bermed liquids in northern area of facility. EPA collected sample of liquid. Results are pending. TCEQ subcontractor recovered liquids and staged in on-site frac-tank.
